MineralSanoPro[®]

SYSTEM FOR THE REHABILITATION OF MASONRY

AFFECTED BY MOISTURE AND SALT

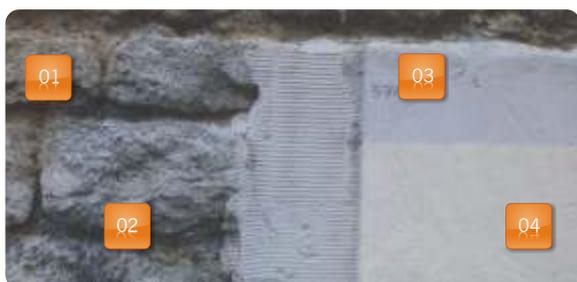
The *epasit* system of renovation mortar * MineralSanoPro consists of a semiopaque coarse plaster, if necessary a base plaster, the *epasit* lpf-WTA white, and a finishing coat or colouring matching with the system. The minimum layer thickness of *epasit* lpf-WTA white is 20 mm.

- 01 Wall
- 02 Coarse plaster - *epasit* hb
- 03 *epasit* lpf-WTA white
- 04 Colouring - *epasit* spf

epasit lpf-WTA white sucks the moisture out of the masonry for a few millimetres. The water evaporates inside the *epasit* lpf-WTA white. Because water vapour cannot transport dissolved salts, they crystallize and are absorbed in the porous structure of the *epasit* lpf-WTA white. Thereby, the surface of the plaster remains dry and free from efflorescences. In addition, the masonry is protected from further destruction by moisture and salts.
